A multidisciplinary approach for the structural restoration of the Katholikon of Dafni Monastery in Attica Greece

A. Miltiadiou-Fezans

Directorate for Technical Research on Restoration, Hellenic Ministry of Culture

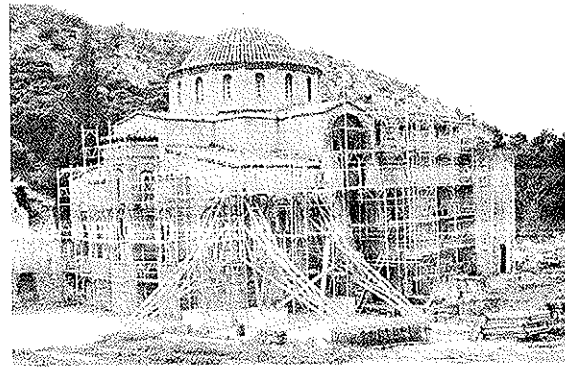
Figure 5. Raking shores installed in the NE corner.

To this end various alternative solutions were examined (Miltiadiou-Fezans et al. 2003a). Figure 4 shows schematically the retained one. In the NE corner of the building, three double-framed steel raking shores was constructed, as in this area a pronounced tilting of the external walls has been noticed and the telltales installed just after the earthquake, indicated further opening of cracks and a tendency of the corner to detach (Fig. 5). In the interior, and in the exonarthex, vertical steel props were built beneath the main arches, in order to provide vertical support to their cracked structure (Fig. 6).

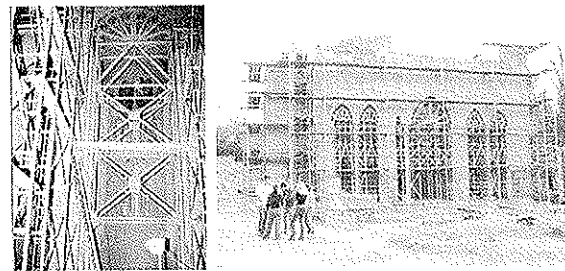
Figure 6. Vertical steel props installed in the interior of the church, and in the exonarthex.

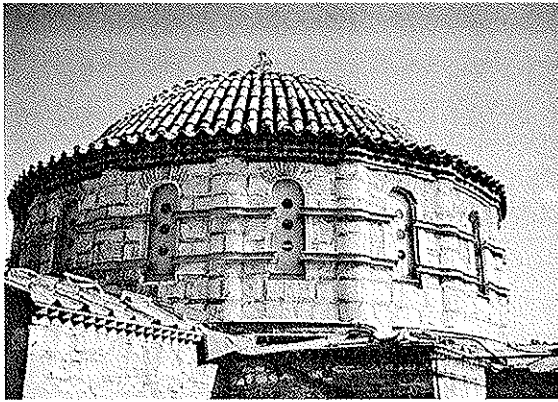
Figure 7. Emergency measures applied to the dome's drum.

Regarding the drum of the dome, specially designed steel elements were constructed to brace the windows and confine in two levels the masonry piers (Fig. 7),

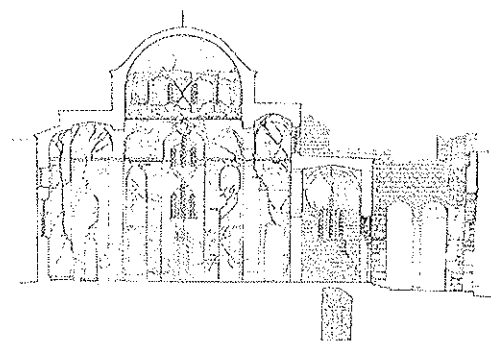
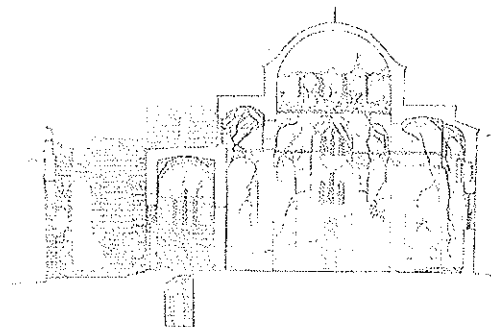
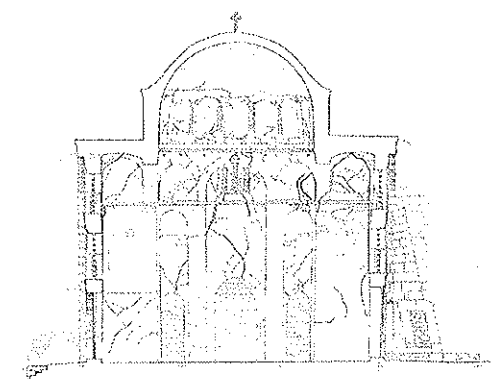
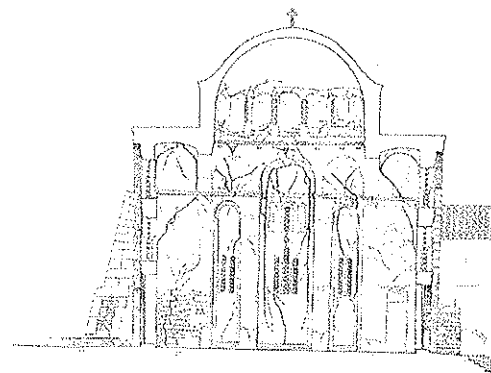
Figure 15. Typical presentation of damages.

The damages were more extensive in the higher parts of the structure, especially in the sanctuary, the arms of the cross and all the arches below the dome area. As shown in Figure 15, the NE and NW small

arches just below the squinches presented severe dislocation near their crown, followed by out of plane deformations of the squinches themselves. Cracks appeared also in all the groin vaults of the church. The structural condition of the dome (reconstructed at 1891 and damaged soon after its reconstruction at 1894), was assessed as extremely critical immediately after the earthquake (Delinikolas et al. 1999, Miltiadou et al. 2003a, 2003b). Horizontal cracks have appeared along the perimeter of the drum (both at its base and top). In the piers of the drum that are situated perpendicular to the East-West direction, horizontal cracks (due to out-of-plane bending) have opened at their top and bottom. In the piers that are situated parallel to the E-W axis, diagonal or bi-diagonal (shear) cracks have appeared. In the intermediate piers, mixed type of (less severe) cracks was observed. This pathological image does seem to confirm seismological data regarding the predominant direction of the 1999 earthquake. Thanks to the external upper metal tie-rod, confining the hemispherical dome near the springing level, the occurrence of severe cracking of the dome's shell was prevented.

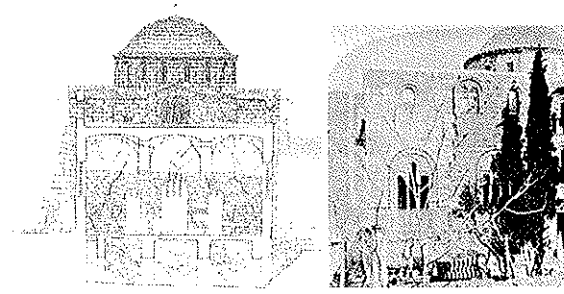
However, even this reconstructed part of the monument presents today a total out-of plane deformation of 90 mm (drawing in Fig. 16). This is another element proving that the feature we observe now in the monument is an inherent characteristic (due to its initial construction scheme and the extended alterations/interventions undertaken during its lifetime).

Figure 16. N-S transversal section in the narthex. The south wall, although reconstructed in 1896 (see photo), presents today a 90 mm out-of-plane deformation.

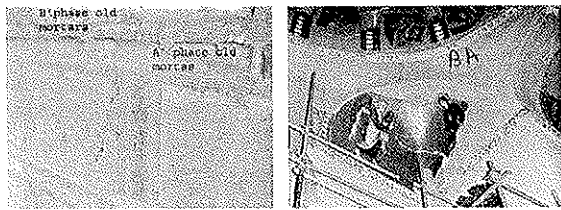
Figure 25. Old mortars of first and second construction phase and cracked mosaics that have to be preserved in situ.

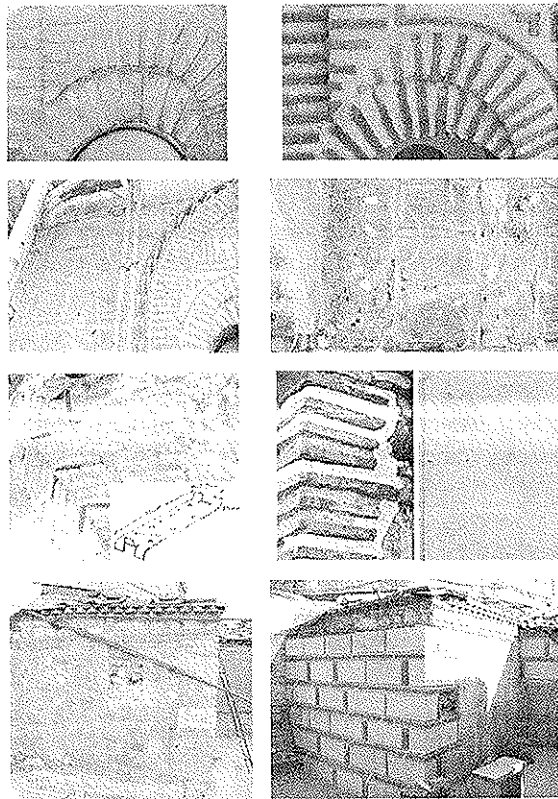
Figure 26. Typical examples of the first phase structural restoration interventions (Recent mortars removal, grouting preparation, stitching of cracks, local reconstruction).

This first phase of masonry repair interventions comprised mainly the following works (Fig. 26): i) very careful removal of plasters and deteriorated pointing mortars applied during previous interventions,

without harming the old ones, adjacent to or underneath them, ii) removal of tiles and other covering and filling materials to reach the extrados of all vaulted structures, iii) stitching of the most severe cracks, using long stones, bricks, or thin titanium plates, iv) few local reconstructions necessary either for the repair of dislocated or collapsed parts or for the restoration of past morphological alterations, v) deep re-pointing where necessary and preparation of the masonry for injection grouting, vi) implementation of injection grouting, vii) removal of all injection tubes, viii) in situ conservation of all deteriorated old mortars using frescoes techniques, ix) execution of all necessary works to ensure the protection of the extrados from rainwater.

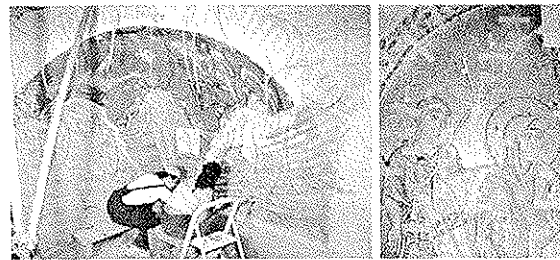
Figure 27. Typical examples of in situ mural mosaics conservation works (including installation of fine tubes for grouting).

In parallel with the works for the masonry repair, the competent Conservators have carried out all the necessary works for the in situ conservation (including grouting) of severely damaged mural mosaics, (Chrysopoulos et al. 2003). As anticipated, in most cases, the cracks on the masonry affected also the mosaics beard on its internal face (Fig. 27).
