Asi Shalom

Conservation and Restoration consultant to the Israeli National Park and Antiquities Authorities

St. Astier NHL 5 plasters and mortars
for high salt saturated historical buildings.

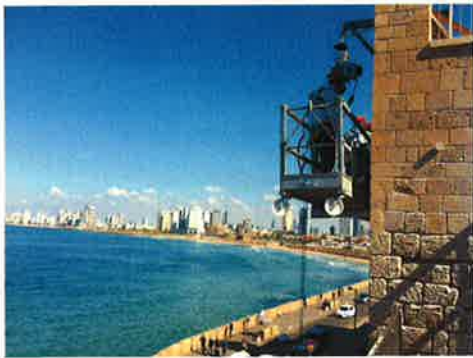
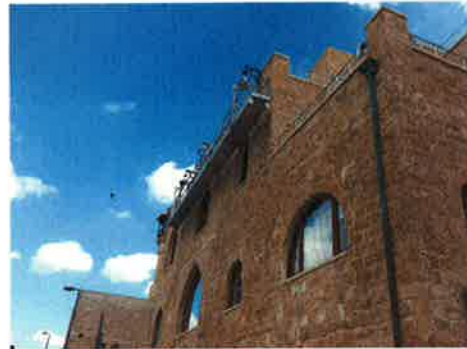
Armenian Historic Building, Jaffa, Mediterranean Coast

Project: typical porous beach stone suffering from sea salts soaked into walls during long periods of abandonment of building.

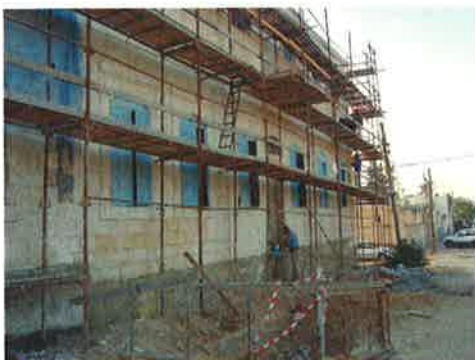
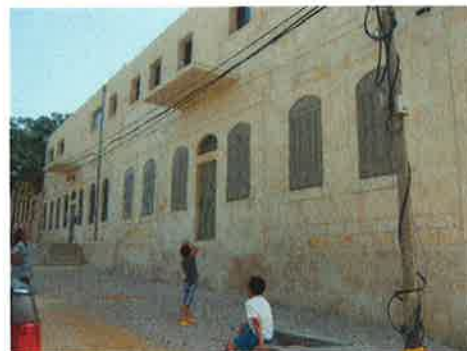
An Historic British Police Building, Be'er Sheva, Historic Quarter

Project: typical soft clay-limestone suffering from salts rising from ground.

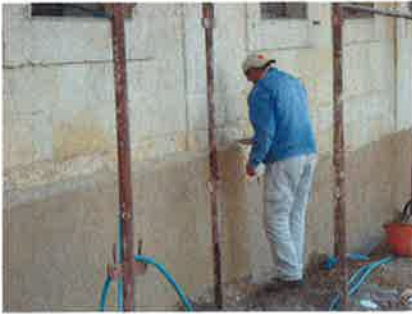
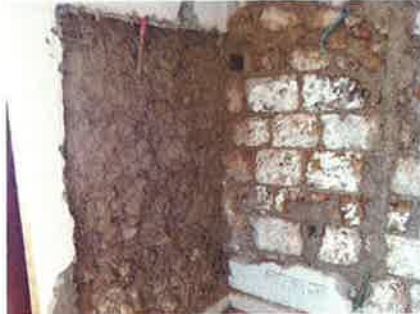
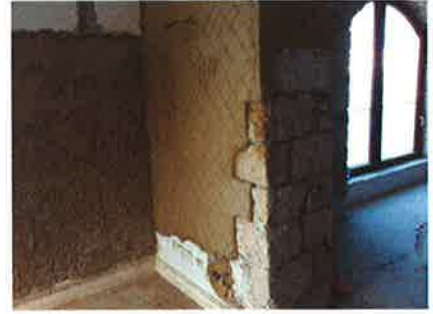
We double out deeper areas first, inserting if necessary pinning materials and bring the area to the required level. The next layers are manually pressed in and worked slightly with a wood or polyurethane float into at not more than 1 cm at the time. The surface is left very rough and small lacunae are left arbitrarily throughout the surface. Since the NHL 5 sets quickly in our climate we can apply another layer the following day. This procedure is followed until the completion of the work.

If the client wish to have a smooth finished surface for aesthetic reasons, a skim coat of 2-3mm is added. This coat is made of 1 part NHL 5 to 4 parts of rough grain graded quartz sand. No pigments are used.

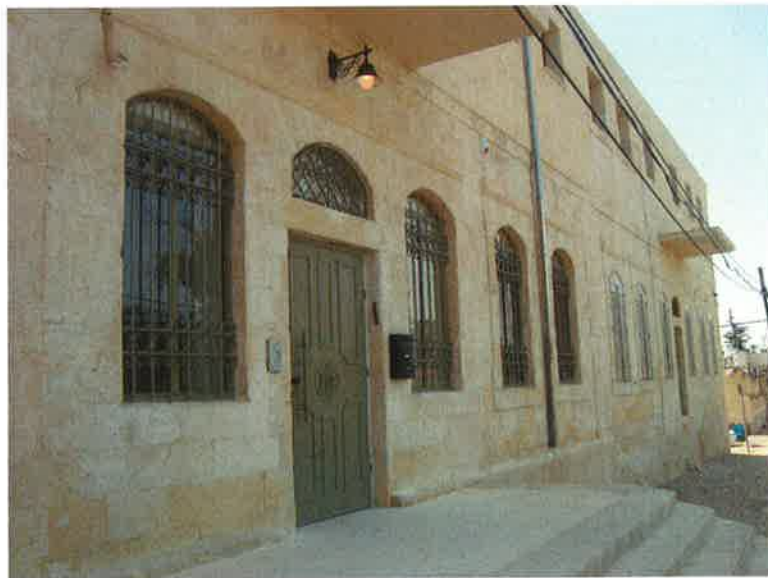
In all cases, the salts contained in the wall have been able to migrate to the surface without any damage to the joints or plasters and easily brushed off.

An efficient, pure lime mortar has done the job that so many other products claim to do at a much greater expense and with, in numerous occasions, poor results.

Composition of the macro-porous St. Astier NHL 5 system

St. Astier NHL 5 1 part to 4 parts aggregate/sand

Aggregate/sand is composed of:

85-90% sharp hard limestone/dolomite aggregate up to 2 mm.

10-15% rough grain graded quartz sand above 2mm.

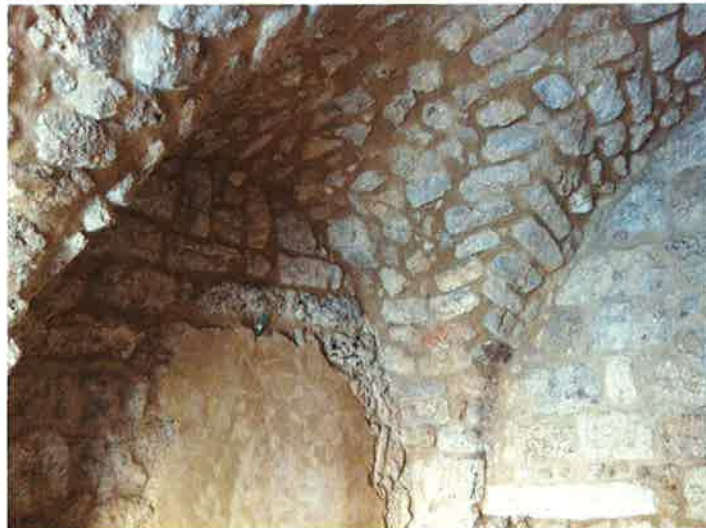
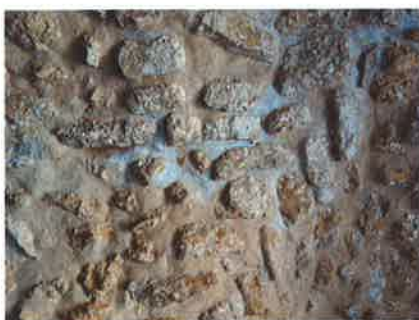
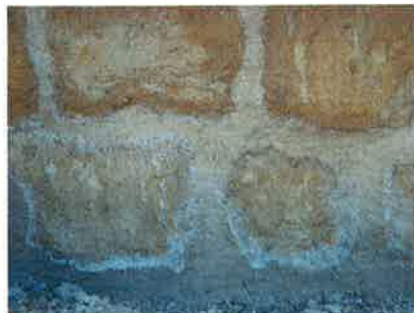
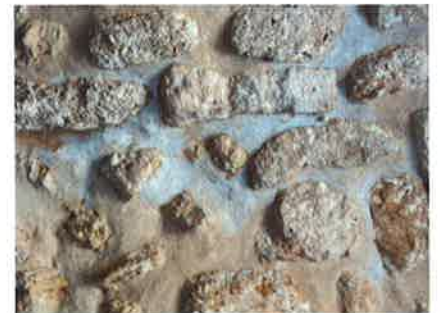
We noticed that the fine textured lime pointing acts as a capillary sponge drawing moisture into the core of the wall and into the soft, unstable stone. With the moisture movement we have the soluble salts which move faster through the weak limestone/porous beach stone, crystallize during changes in their relative humidity, causing decay and damage.

The macro-porous system, having a minimum thickness of 5-6 cm. in the joints contains voids that allow the salts, on their way to the surface, to crystallize and eventually move again to the surface without producing an heave effect which causes cracking and deterioration of joints, plaster mortars and weak masonry.

For that reason we apply the NHL 5 system mentioned above as a drainage system allowing moisture to move in but more importantly move out of the wall to the surface. Allowing free movement keeps the moisture in the pointing mortar and the joints and not in the unstable stone. The final surface of the worked joint is left rough and not polished smooth.

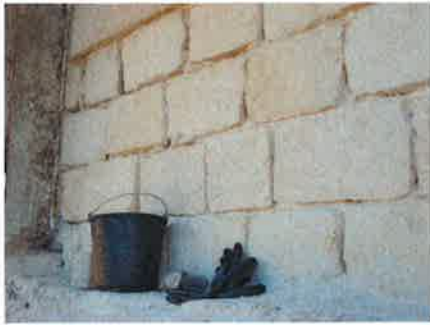
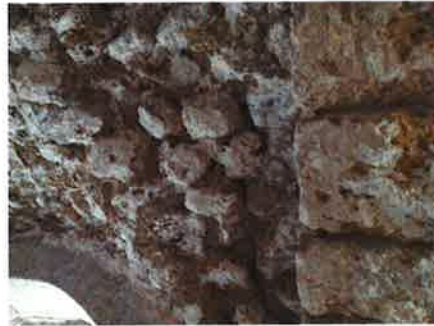
- Understanding the monument's original building techniques and materials.
- Assessment of the type and extent of the salt damage, the decay process and the probable causes.
- Elimination of all surrounding causes which directly affect the salt movements.
- Dismantling of salt affected, existing pointing and plasters.

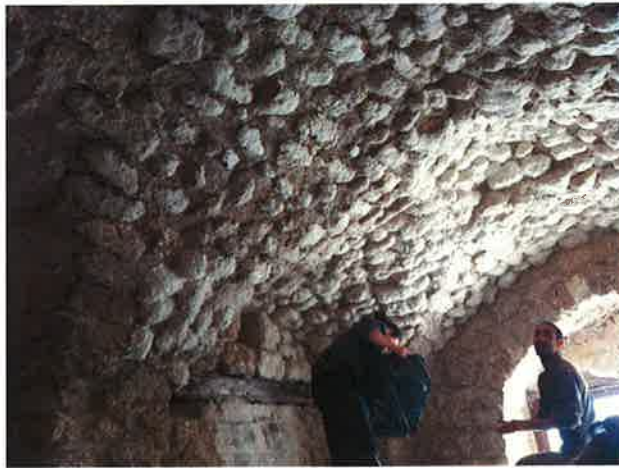
- Desalination with a poultice containing methylcellulose and distilled water for 2-3 days,

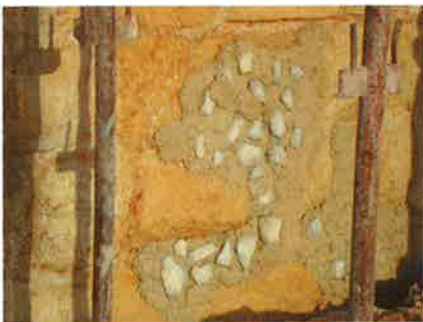
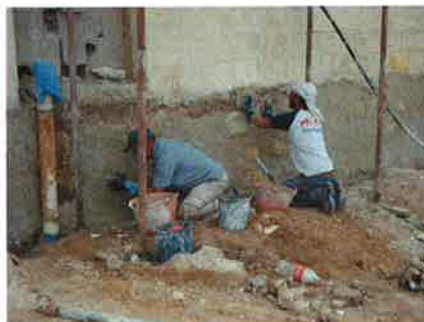
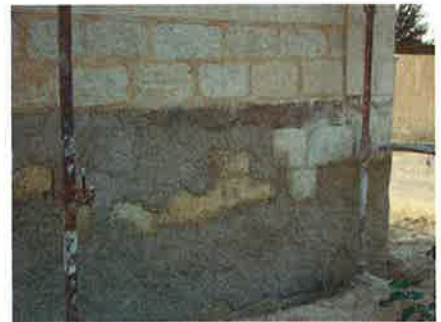
- Application of 5-6 cm. deep pointing and 2-3 layers of 1 cm. thick plaster composed of the NHL 5 macro-porous system.
- Monitoring during the change of seasons.

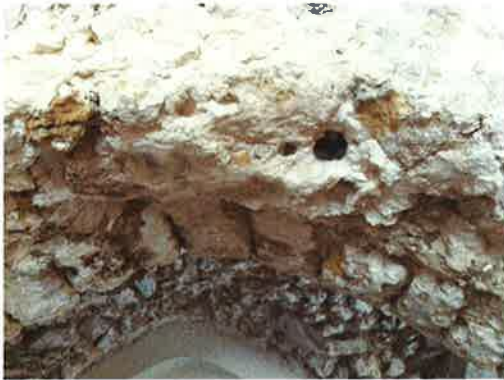
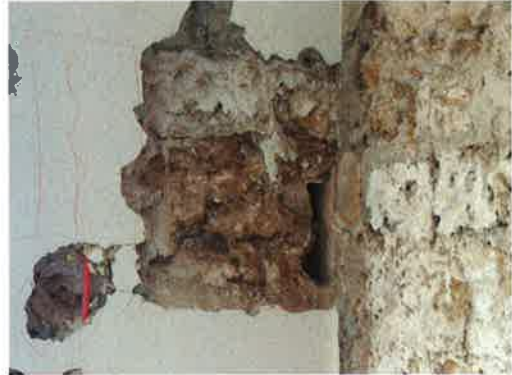
Jaffa Project: damage done by salts soaked from sea and modern cement plasters.

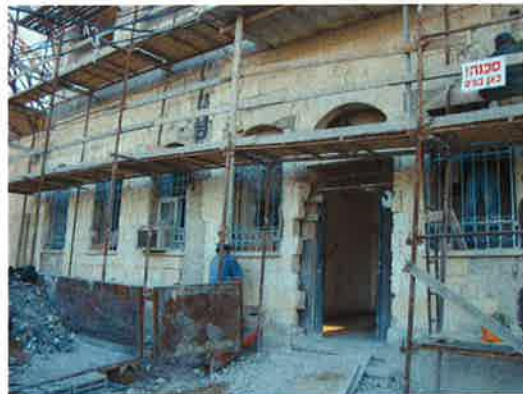
Be'er Sheva Project: damage done by rising salts from ground and application of modern cement plasters.
