A multidisciplinary approach for the structural restoration of the Katholikon of Dafni Monastery in Attica Greece

A. Miltiadiou-Fezans

Directorate for Technical Research on Restoration, Hellenic Ministry of Culture

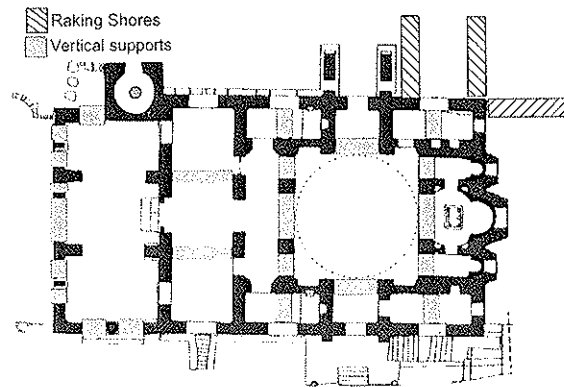
Figure 4. Plan of the Katholikon and schematic presentation of the arrangement of the raking shores and vertical props.

To this end various alternative solutions were examined (Miltiadiou-Fezans et al. 2003a). Figure 4 shows schematically the retained one. In the NE corner of the building, three double-framed steel raking shores was constructed, as in this area a pronounced tilting of the external walls has been noticed and the telltales installed just after the earthquake, indicated further opening of cracks and a tendency of the corner to detach (Fig. 5). In the interior, and in the exonarthex, vertical steel props were built beneath the main arches, in order to provide vertical support to their cracked structure (Fig. 6).

Both the raking shores and the vertical props were self supported elements, which would be activated only in case of further increase of the deformations of the structure. Thus, between the metal framework and masonry walls, a 12 cm full layer of wooden beams and wedges (together with a 3 mm soft packing) were inserted, to provide good contact with the masonry without harming the surfaces, while allowing relative movement, unless the structure did start to move towards them. Moreover, the upper part of the exonathex walls and the NW and SW piers were confined using steel plates and bars.

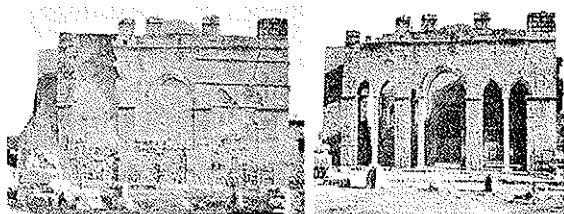
Figure 11. West façade of the exonarthex before and after Stikas restoration interventions (photos Stikas, 1962).

In that period of 1955–1960 the ottoman interventions were removed from the exonarthex (Fig. 11)

and the Cistercian construction phase was restored by Stikas (Stikas 1962). The collapsed part was rebuilt and the missing ionic columns were replaced by masonry piers. A concrete beam was installed in the interior of the reconstructed parts, without affecting the byzantine remains of the SW pier. The upper part of the SE chapel was also reconstructed, while extended local re-pointing took place in various areas of the Katholikon, using mainly cement based mortars. Fortunately the non deteriorated old mortars were not removed. Thus, they survived to our days in better condition than those used by Stikas, which presented extended decay and during the recent restoration works were removed.

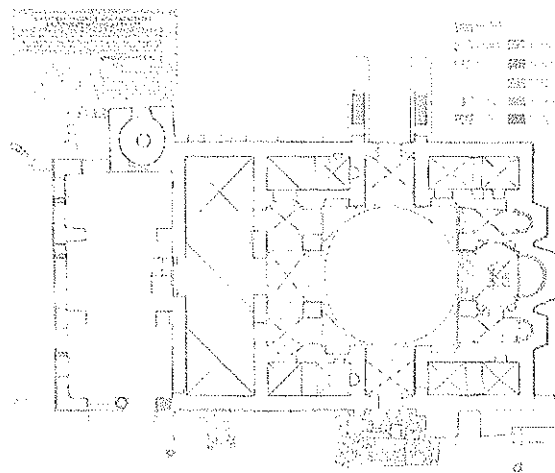
Figure 12. Interventions to the monument: Plan.

Figures 12 to 14, taken from Delinikolas et al. 2003, present the historical pathology and past interventions on drawings. The reconstructed parts of the monument are shown with solid colors. Yellow: 13th–15th c., orange: 1891, green: 1895, purple: 1897–1907, dark blue: 1955–60.

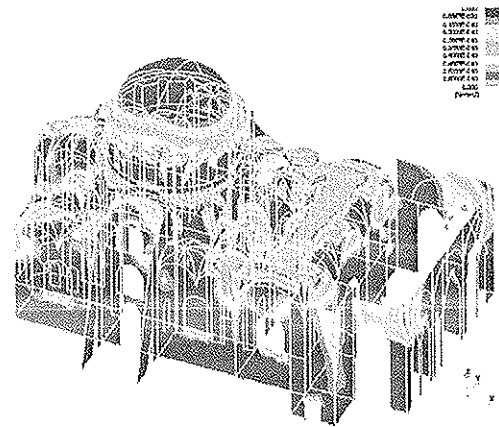
Figure 18. Inner face of shell elements. Tensile stresses due to self-weight of the structure.

Figure 18 shows the calculated stresses for the inner face of shell elements, due to vertical loads. Irrespective of the accuracy of numerical values of stresses, one may clearly distinguish the vulnerability of the region of arches and domes (especially in the west part), even for the self-weight of the monument alone. As expected, tensile stresses are developed in the apex

of several arches, in the groin vaults of the narthex, in the base of the cupola and that of its drum, as well as in the four squinches. The obtained results are conform with the qualitative interpretation of the pathology of the monument and they prove the inherent vulnerability of the structural system, in which (a) a stiff central cupola is resting (through the drum) on four major arches parallel to the two main axes of the church (see Figures 3, 4), as well as on four arches oblique in respect with the longitudinal and the transverse axis, (b) the vertical, as well as the horizontal component of the self weight of the whole system of (intersecting) groin vaults arranged around the central dome, are transferred to rather flexible stone masonry piers, and (c) there are not currently ties in the arches and vaults, or other elements to confine critical structural elements or link the various parts among them. Therefore, the tendency of the structural system to deform laterally in its upper region is expected to be apparent even under self-weight alone.

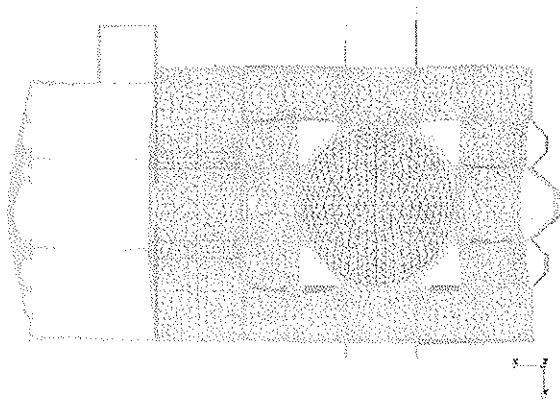
Figure 19. Deformed shape of the monument in-plan under self-weight.

This working hypothesis seems to be confirmed by the deformed shape of the structure in-plan, shown in Figure 19. One can even observe the more pronounced lateral deformation along the N–S axis of the

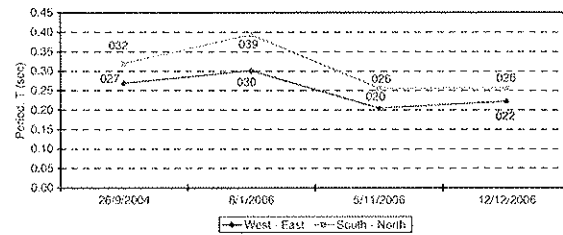
Figure 28. Variation of the period of the first mode.

As shown in Figure 28, during the earthquake of 08/01/2006 occurred after the urgent measures and while preparing the masonry for grouting, the natural period of the first mode was increased, and hence the stiffness of the structure was decreased. This is totally expected, as only local deep re-pointing and stitching of some cracks had been applied at that moment, while the emergency measures have not been designed to undertake seismic actions. Moreover an increase of damping was recorded. These results may indicate a slight deterioration of damages. On the contrary, as a result of the implementation of grouting injections up to the springing level of groin vaults, the period and the damping of the first mode were decreased, along the EW and the NS directions. This result was reached by analysing the data of both seismic events, happened three and four months after the first grouting period. Thus, it was proved that the effect of interventions and more specifically of grouting on the overall behaviour of the structure can be evaluated by a seismic monitoring system. This promising finding led to the decision to install in 2007 complementary instrumentation, with the aim to cover the whole structure.
